WL-TR-91-3088

COUPON AND BIRDSTRIKE TESTING OF
F-111 ADBIRT WINDSHIELDS WHICH HAVE
BEEN SUBJECTED TO SIMULATED PRESSURE/
THERMAL SERVICE LIFE

Daniel R. Bowman
University of Dayton
300 College Park Avenue
Dayton, Ohio 45469-0110

Interim Report for Period February 1990 - October 1990

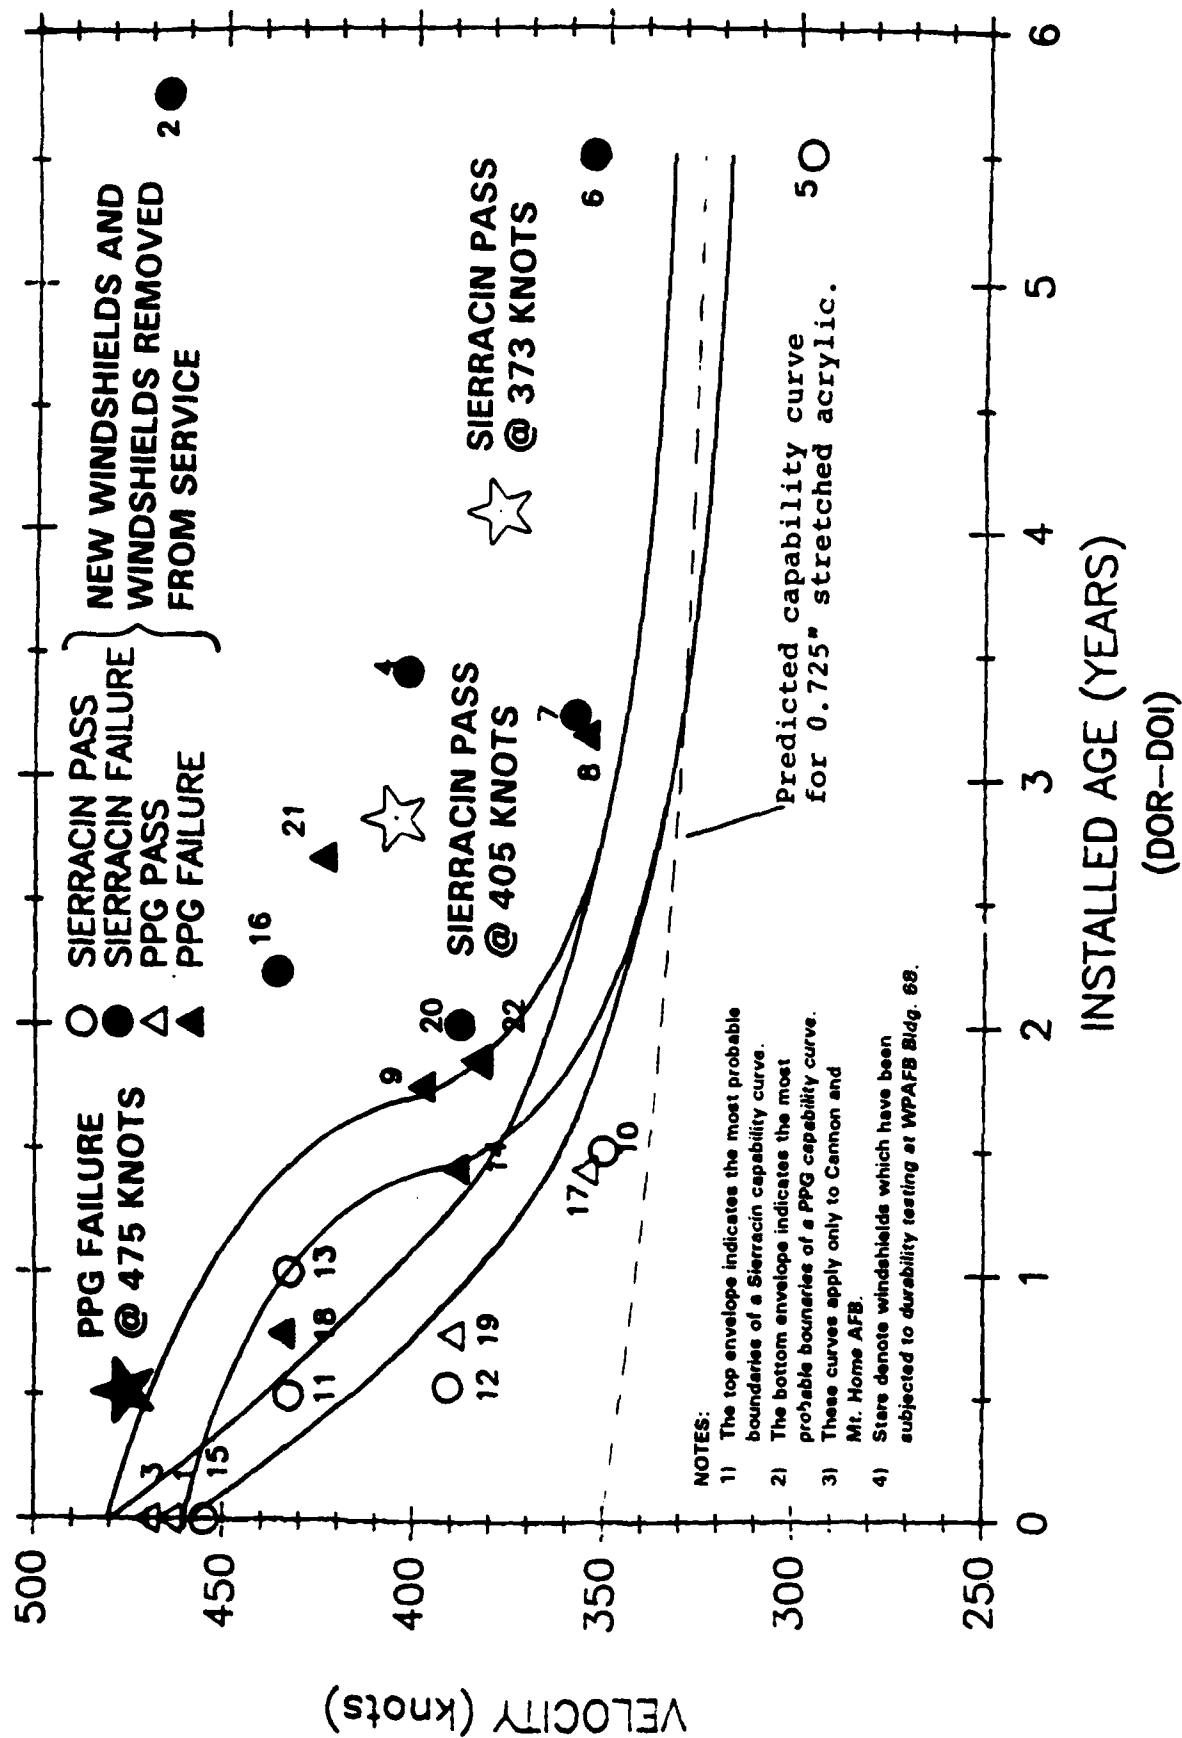
Figure 5.9. Birdstrike Test Results of New, Service Aged, and Durability Facility Aged F-111 ADBIRT Windshields.

in Figure 5.9 on top of the test data from the birdstrike testing program conducted by UDRI of in-service aged F-111 windshields, Reference 1.

The Sierracin and Swedlow windshields passed birdstrike tests when shot at 50 knots above the capability curves which resulted from birdstrike testing of the in-service aged windshields. The PPG windshield failed at 45 knots above the capability curve (note there were a significant number of fatigue cracks in this windshield), however 475 knots is right at the limit of the capability for new windshields using the UDRI hardware. The full-scale durability facility currently simulates pressure/thermal profiles from the flight environment and cleaning operations, but does not include UV light, moisture, flightline cockpit heating, or ambient thermal effects (although several of these are being considered for incorporation into the facility). The differences in birdstrike degradation between simulated and actual service life are most likely a result of those environmental factors which are not simulated in the durability facility.
